POPPLETON HISTORIC STUDY

B-2671

<u>Block</u>	<u>Lot</u>	<u>Address</u>	
234	1-8	1101-1115 Hollins Street	MAG-1 #0426715411
		(Opposite the Hollins Market)

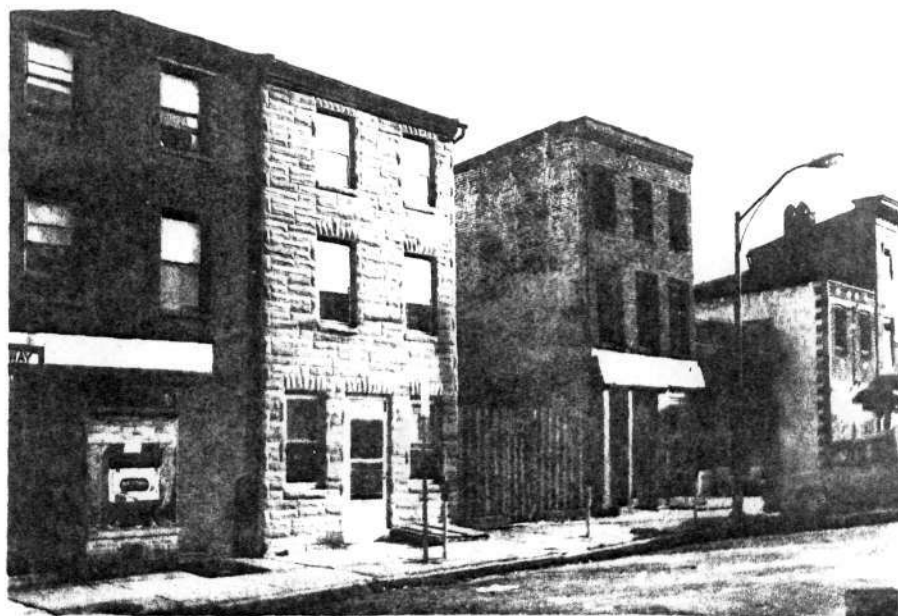
The eastern half of this Hollins Street block developed first; in 1851 there was but one house west of Carlton Street. Much of this early building has been replaced, but the set-back house with a shed roof at 1105 is certainly either original (i.e., before 1851), or in the same site as an earlier house.

After 1851, it grew rapidly as activity at the Market increased. Rebuilding has occurred -- the bath house is an example. The entire street should be rehabilitated. Numbers 1101 and 1115-1117 are original shop fronts.

Numbers 1107, 1115 are vacant. Others are used for storage, warehousing, etc., which immediately uglifies buildings with the blocked-up or blanked-out windows and doors. A redesign of this block in keeping with the commercial character of the Market is in order. A mix of residential and first-floor commercial would be ideal. The difficulty of getting parking elsewhere probably means the unsightly continuous row of cars have to remain at curbside.
